Dam Safety Inspection Report

Name: **Lake Paran Dam**
State ID: **17.01** NID ID: **VT00006**
Hazard Class: **High Hazard Potential**

Town: **Bennington**
Watershed: **Walloomsac River**
Stream: **Paran Creek**

Inspection date: 11/23/2022 14:29

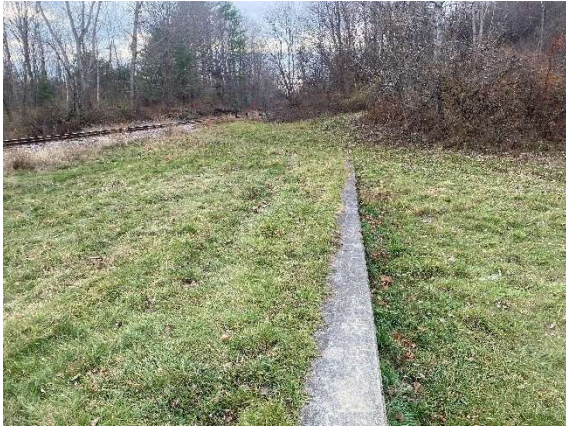
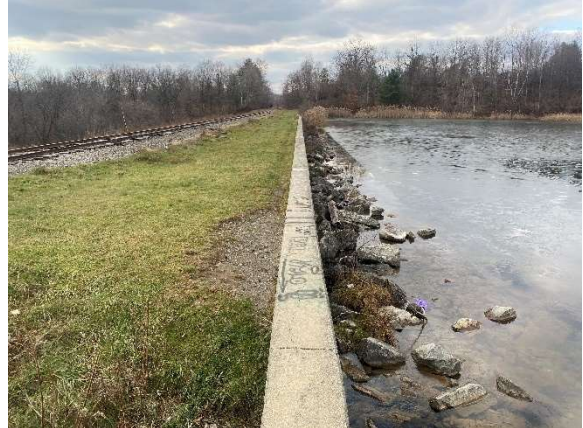
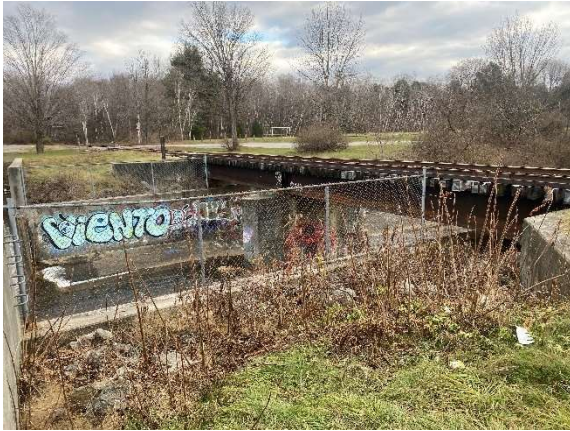
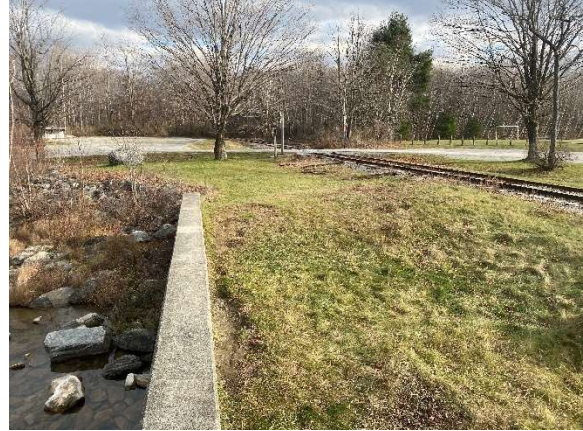
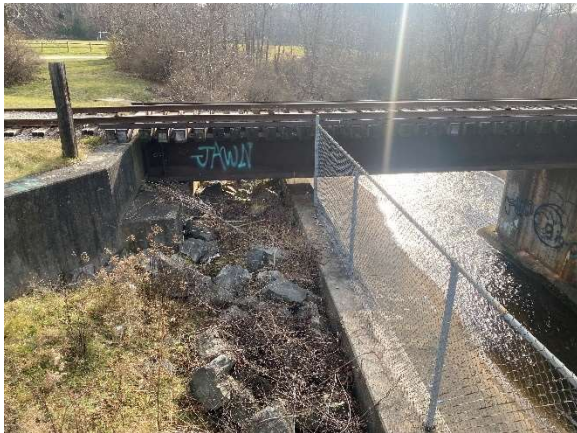
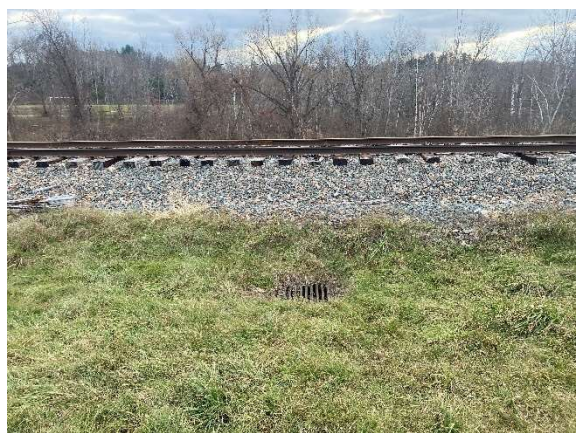
Crest images

Crest	
Length: 720 ft	Width: 50 ft
Freeboard: Principal spillway to crest: 6 ft	
Additional comments: Minor rutting from mowing operations. Crest behind concrete upstream wall is lower than the top of concrete wall. Earthen portion of crest is not level and minor erosion from stormwater runoff observed. A stormwater catch basin is located between in the concrete upstream wall and railroad tracks to help drain ponding stormwater. Active railroad bed on dam crest, timber ties set in crushed stone ballast.

Crest issues	Action
Minor erosion, and rutting.	<input type="checkbox"/> None <input type="checkbox"/> Monitor <input checked="" type="checkbox"/> Maintenance <input type="checkbox"/> Engineer
Un-even crest, poor drainage.	<input type="checkbox"/> None <input type="checkbox"/> Monitor <input checked="" type="checkbox"/> Maintenance <input type="checkbox"/> Engineer

Maintenance level recommendations	
<i>Crest area</i>	<ul style="list-style-type: none"> • Fill ruts, depressions, and or puddles on the dam crest with compacted granular fill to match surrounding grades. Topsoil, seed, and mulch to establish grass cover. • Repair eroded areas and promote drainage on the dam crest. • Place erosion stone at the end of the dam crest storm water culvert.
<i>Downstream slope area</i>	<ul style="list-style-type: none"> • Regularly monitor seepage, leakage, and/or wet areas for changes in flow, turbidity, or size. • Monitor and fill holes on the downstream slope after removing deleterious materials with compacted granular fill to match surrounding grades. Seed and mulch repaired areas. If necessary, remove nuisance animals from the dam and surrounding area or otherwise address the cause of the holes.
<i>Spillways</i>	<ul style="list-style-type: none"> • Monitor and repair minor concrete cracking and deterioration. • Monitor vandalism and graffiti.

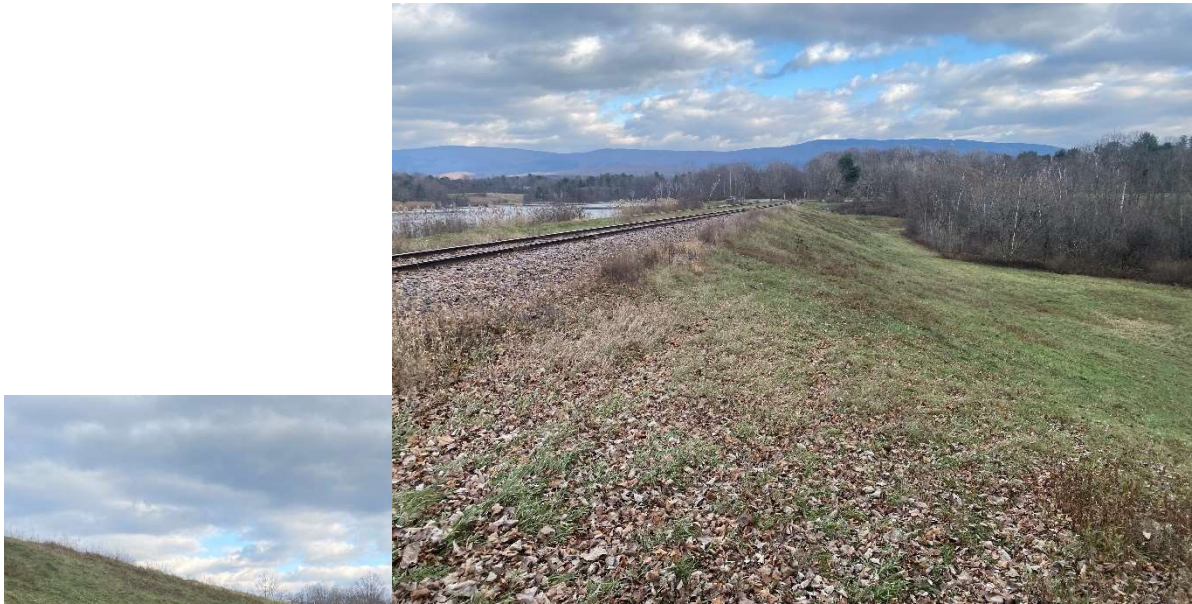
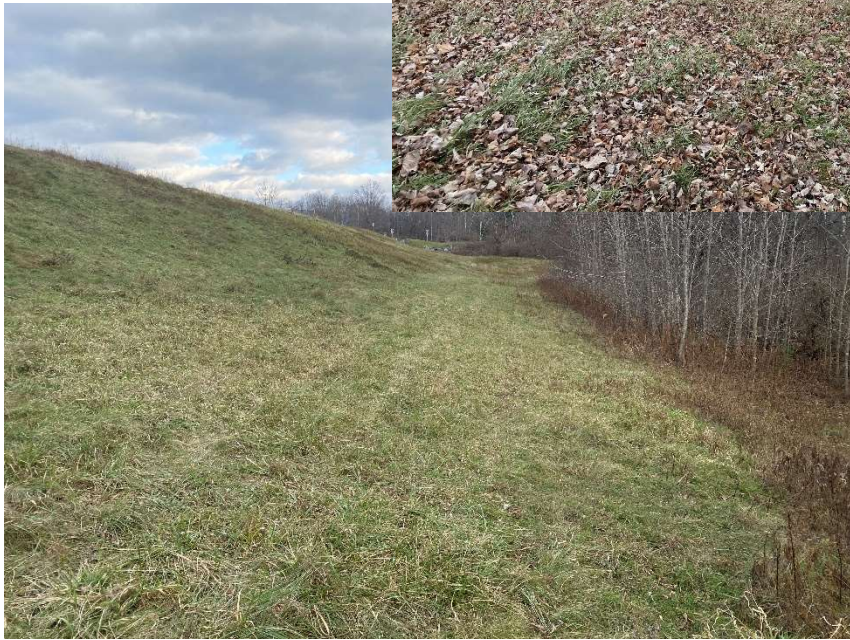
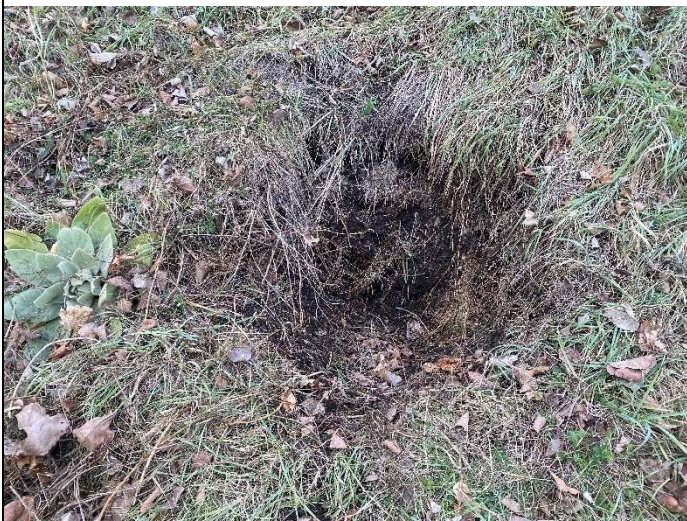
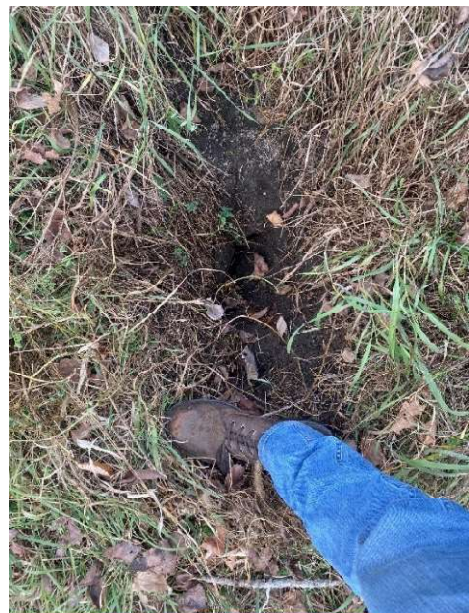
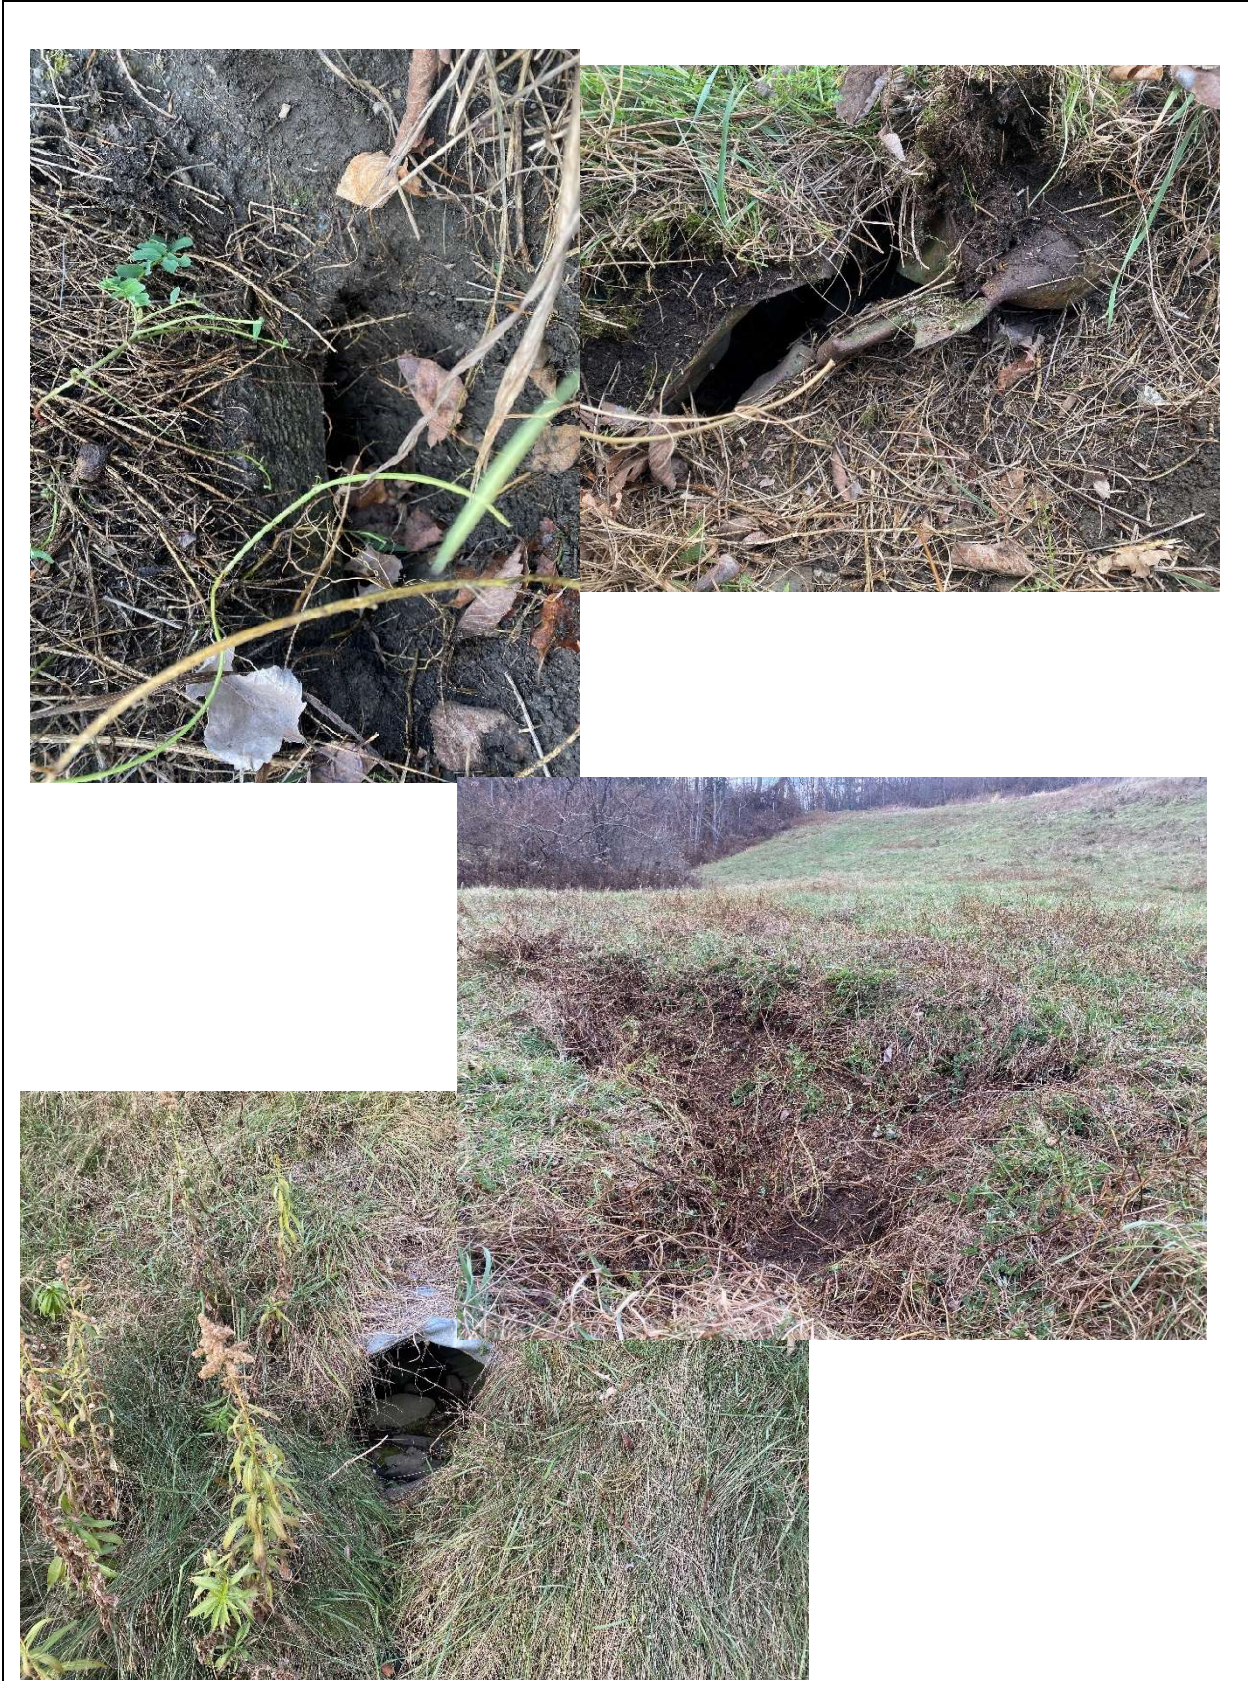
Downstream slope images

Downstream Slope
<p>General slope inclination: 2.5 H:1V (slopes are within generally accepted stable inclinations). Downstream slope appears stable based on visual observation under current loading conditions. There are no isolated areas where the slope is over steepened.</p>
<p>Additional comments: There are areas of soil loss on the downstream slope primarily near the right abutment. It is unclear if these are the results of vandalism or an active dam safety deficiency such as animal burrowing or sinkholes that have developed. Some of the holes appear to be filled in with rocks/junk. Further investigation should be performed to determine the cause of these holes and repair by removing placed boulders/trash/debris and filling in with embankment compatible granular fill, topsoil, seed & mulch. The stormwater culvert which discharges at the toe of the downstream slope does not have any stone placed around it to prevent erosion.</p>

Downstream slope issues	Action
<p>Depressions/Sinkholes Approximate width: 4 ft x 4 ft (varies by location) Approximate depth: 1 to 1.5 ft (varies by location) Location: Right End, Center</p>	<p> <input type="checkbox"/> None <input type="checkbox"/> Monitor <input checked="" type="checkbox"/> Maintenance <input type="checkbox"/> Engineer </p>

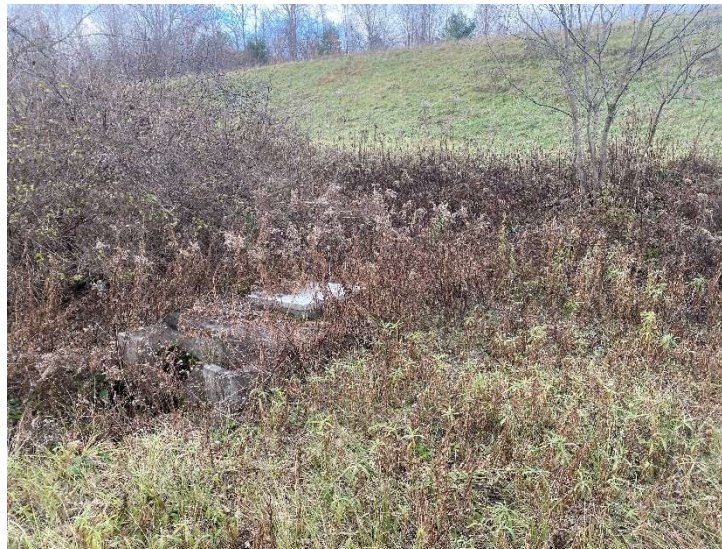
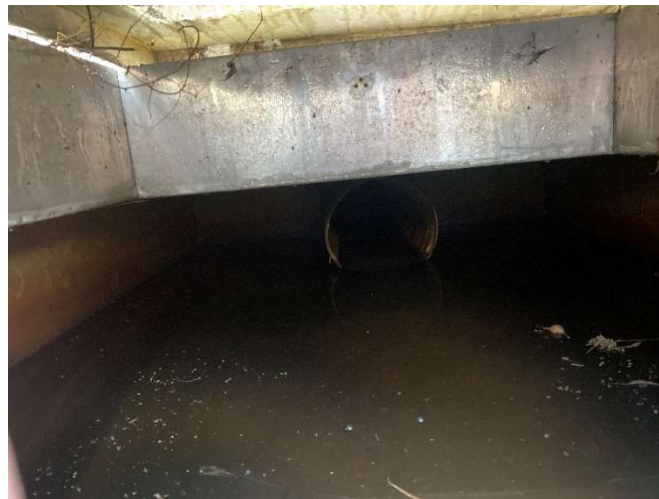
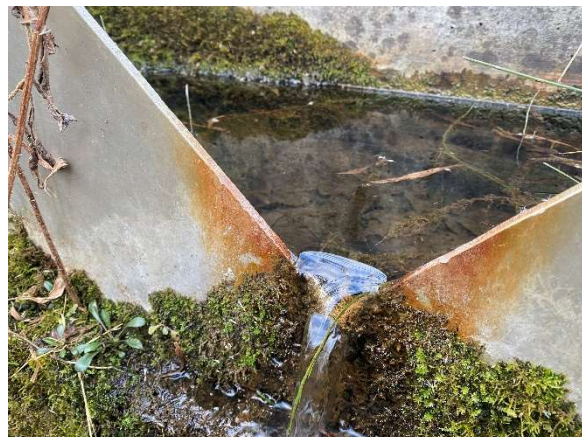
Toe drain images

Toe drains					
Tag: Collection Weir					
Flow Depth:	1-inch	Measure method:	Ruler	Location:	Near center of embankment.
Action required: <input type="checkbox"/> None <input checked="" type="checkbox"/> Monitor <input type="checkbox"/> Maintenance <input type="checkbox"/> Engineer					
Comments: Toe drain is a 12" pipe which flows into a manhole and then outflow passes over a v-notch weir. The weir had 1 inch of flow depth. The manhole was partially filled with loose fines (assumed from toe drains/embankment), some iron-colored deposits.

<i>General</i>	<ul style="list-style-type: none"> • Perform an update to the Emergency Action Plan at least every other year and provide the updates to all key contacts. • On a regular basis and following the application of unusual or extreme loading conditions, perform monitoring of the dam and its appurtenances. Report any unsafe condition to the Dam Safety Program.
<i>Embankment</i>	<ul style="list-style-type: none"> • Continue mowing the grass surfaces of the embankment and auxiliary spillway once to twice annually. • Remove pond vegetation from the upstream riprap slope. Supplement riprap with smaller stone to fill large voids. • Add topsoil, seed, and mulch bare spots on the embankment to reduce the risk of erosion. • Clean out the toe drain vault/manhole structure and start to track the rate of sediment/fines deposition.

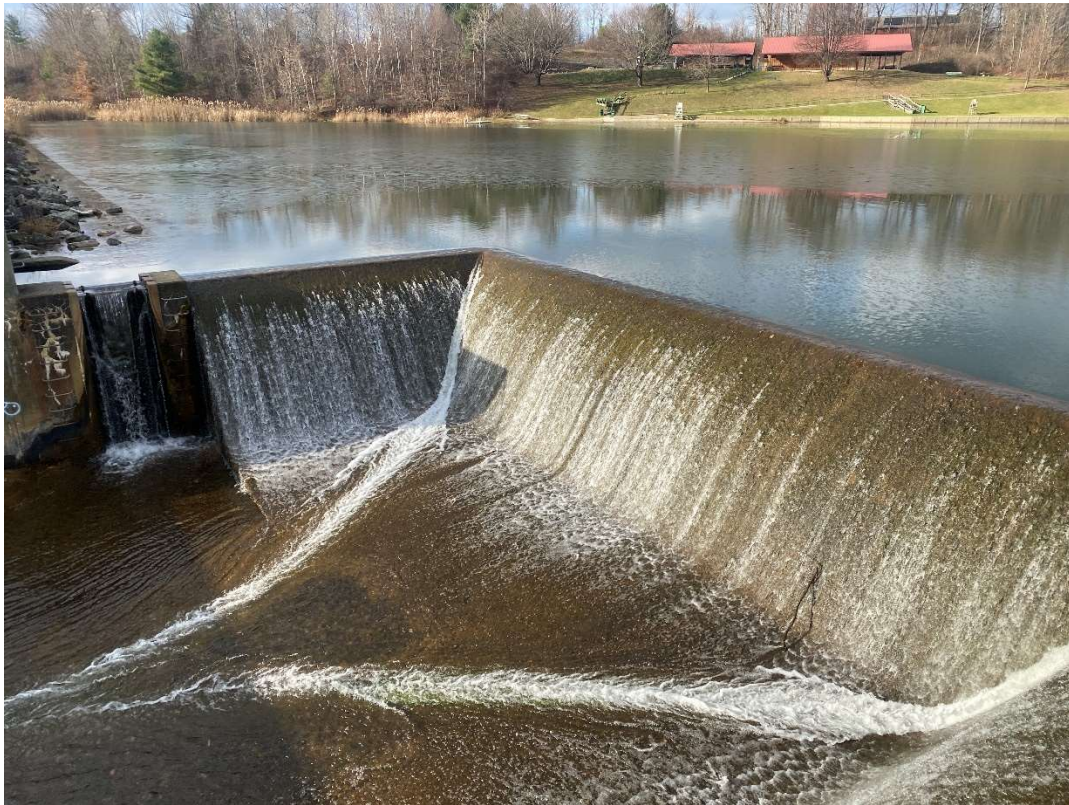
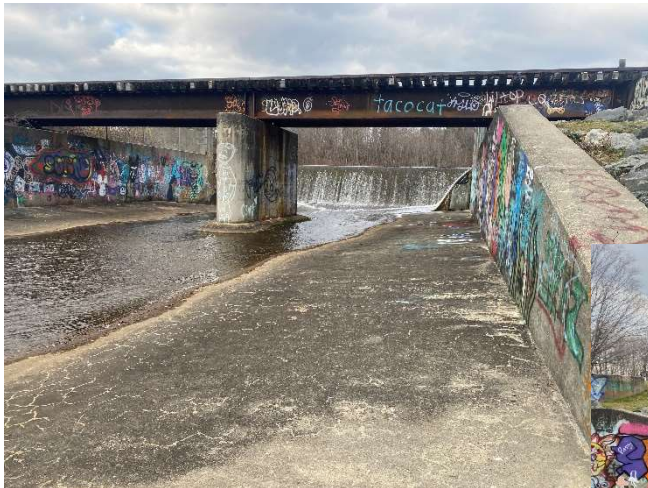
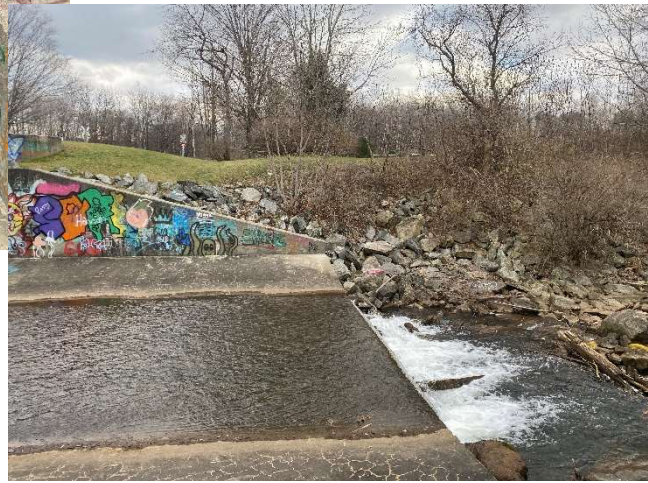
Principal spillway images

Principal Spillway	
Spillway type: Weir	Primary material: Concrete Weir: Ogee-style
Spillway location: Left abutment	
Water level measured against principal spillway crest: 1-inch Erosion control structures: End Sill	
Spillway components: <input type="checkbox"/> Anti-vortex plate <input type="checkbox"/> Filter Diaphragm <input type="checkbox"/> Training Walls <input type="checkbox"/> Flashboard <input type="checkbox"/> Trashrack <input type="checkbox"/> Other:	
Additional comments: Did not inspect upstream face of Ogee (submerged). The concrete chute and downstream training walls appear to be in satisfactory condition. Vertical alignment appeared satisfactory. There was a small section along the left side of the chute that had peeled/spalled.

Principal spillway issues	Action
Deteriorating concrete Issues: <input type="checkbox"/> Bug holes <input type="checkbox"/> Popouts <input type="checkbox"/> Isolated crack <input type="checkbox"/> None <input type="checkbox"/> Hairline crack <input type="checkbox"/> Honeycombing <input type="checkbox"/> Exposed rebar <input checked="" type="checkbox"/> Monitor <input type="checkbox"/> Efflorescence <input checked="" type="checkbox"/> Scaling <input type="checkbox"/> Disintegration <input type="checkbox"/> Maintenance <input type="checkbox"/> Spalling <input type="checkbox"/> Crazed/Map cracks <input type="checkbox"/> Other: <input type="checkbox"/> Engineer	
Location: Entire Surface	
Deteriorating stop logs Comments: Leakage observed through gaps between stoplogs, and around ends of stoplogs (between interface with steel channel the stoplogs sit in).	<input type="checkbox"/> None <input checked="" type="checkbox"/> Monitor <input checked="" type="checkbox"/> Maintenance <input type="checkbox"/> Engineer
