Dam Safety Inspection Report

Name: **Lake Paran Dam**
State ID: **17.01** NID ID: **VT00006**
Hazard Class: **High Hazard Potential**

Town: **Bennington**
Watershed: **Walloomsac River**
Stream: **Paran Creek**

Inspection date: 11/23/2022 14:29

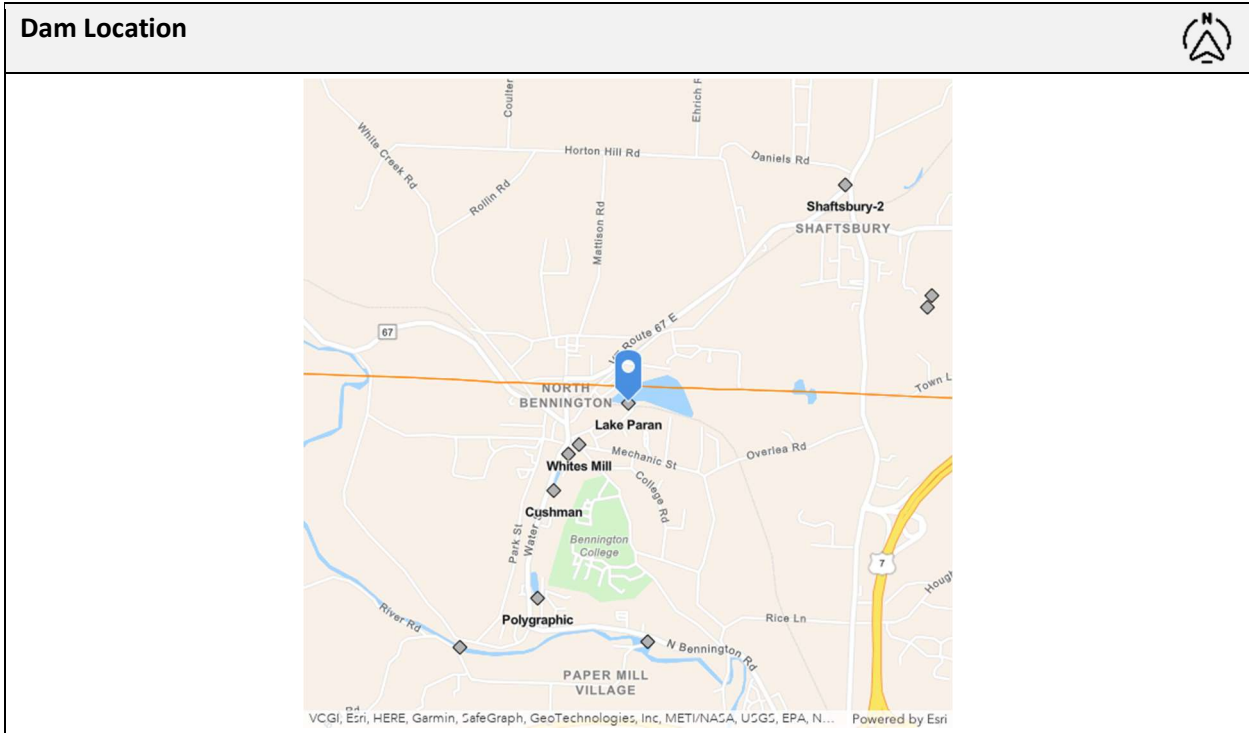
Dam Description/Background
<p>Lake Paran Dam is an earth embankment dam with a principal spillway and stoplog channel. The dam is currently classified as a HIGH hazard potential. According to file information, the dam has a total length of 720 feet and a structural height of 25 to 30 feet. The upstream face of the dam consists of an approximately 3H:1V slope with an embedded, vertical concrete wall to the right and left of the spillway. The crest of the dam is at approximately El. 653 (National Geodetic Vertical Datum, NGVD in feet) and supports an active railroad that crosses over the spillway discharge channel via a steel bridge. The downstream slope of the dam is approximately 2.5H:1V. The principal spillway consists of a three-sided, concrete ogee-style weir that is approximately 126 feet in length and at El. 647.</p> <p>The spillway discharges into a concrete lined channel that passes through the embankment and discharges to Paran Creek. The stoplog channel is about 4 feet wide, embedded in the right side of the principal spillway, and consists of a dual set of timber stoplogs. The dam does not appear to have a low-level outlet and it does not have an auxiliary spillway.</p> <p>Lake Paran at normal pool is approximately 38 acres and the normal and maximum storage capacities of the dam are approximately 285 acre-feet and 535 acre-feet, respectively. The drainage area of the dam is estimated to be 9,312 acres. The dam was originally constructed in 1851 for water storage for downstream mills. In 1955 the timber spillway was replaced with a concrete spillway. The dam was deemed unsafe by the United States Corps of Engineers in 1978 and was reportedly reconstructed circa 1979.</p>
